Coatings extend condenser life

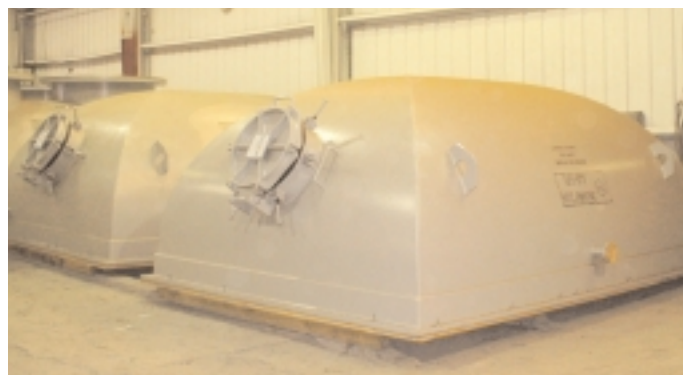
5. Coated waterbox. At many fossil-fueled plants, condenser system's unlined water boxes and uncoated steel tube sheets often experience severe corrosion over time. Properly coated water boxes will significantly extend equipment life. Courtesy: Bridgewater Protective Coatings Inc.

Fiberglass, phenols, and vinyl ester also are used to extend the life of systems in harsh-chemical environments. Sometimes coatings or topcoats of organic or inorganic zinc, alkyds, acrylics or silicone alone will do the job. Inorganic zinc and silicone, for example, are good choices for hot surfaces (Figure 5).
